DSTO-TR-0366

Evaluation of Innovative NDI
Methods for Detection of
Widespread Fatigue Damage

P. Khan Sharp,
D.E. Rowlands and G. Clark

**Airframes and Engines Division
Aeronautical and Maritime Research Laboratory**

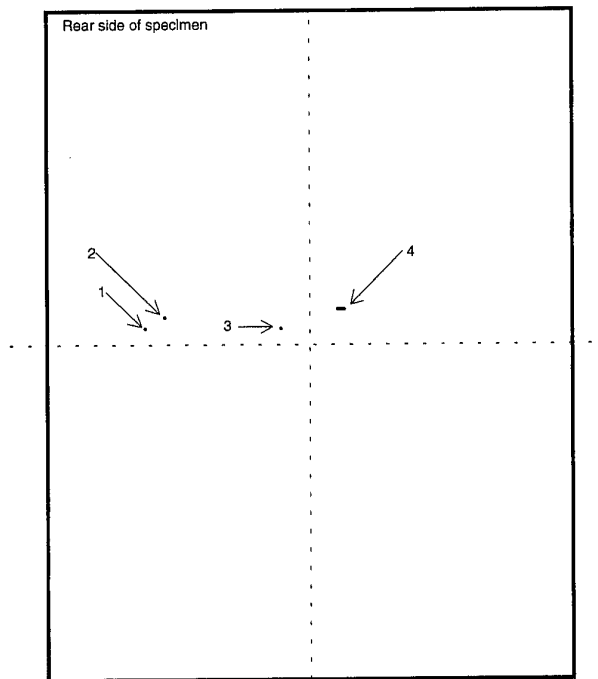
Figure 24: A schematic of the location of the four cracks detected with holographic interferometry.

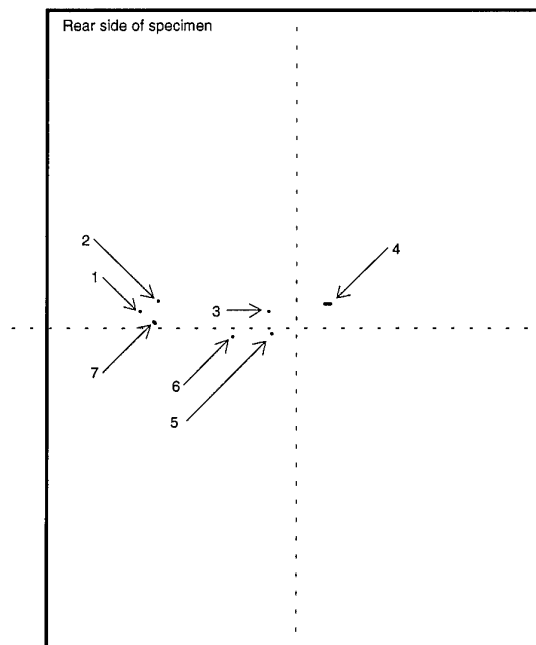
Figure 28 is a schematic of the crack locations observed after program 29. Plate No. 24 clearly shows a number of cracks present, Figure 29.

Figure 28: More cracks were located as shown in this schematic. Note that crack No.4 does not appear on this image.

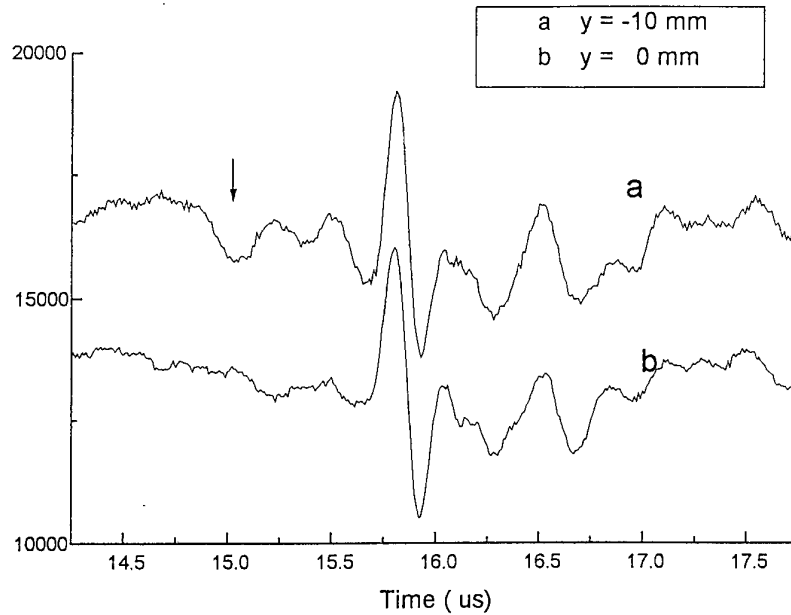
Figure 33: A typical waveform transmission from the test [3]. The difference between the two waveforms is the arrowed peak, which is attributed to a crack.

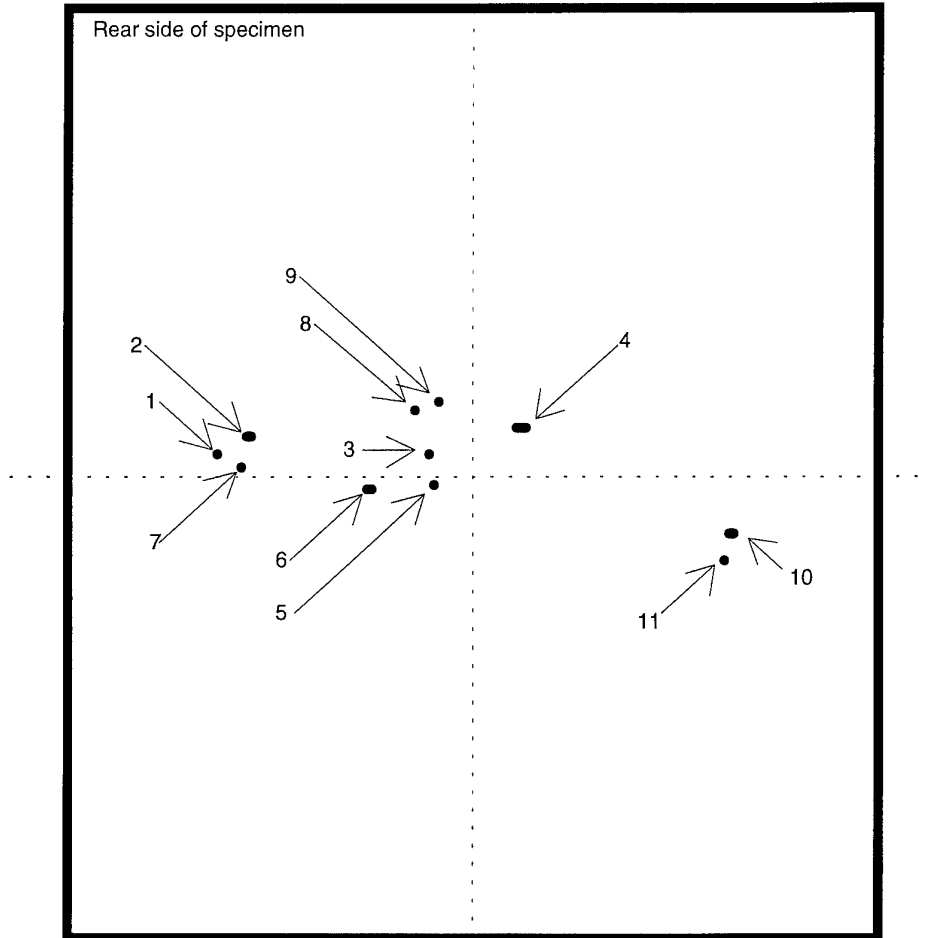
Figure 36: The eleven cracks found by fluorescent dye penetrant on the back of the specimen (holographic interferometry side). The visual intensities are a good indication of the crack size and are as follows; crack 4-very bright, cracks 2, 6, 10-bright and cracks 1,3,5,7,8,9,11-weak.
